Making Hi Tech Radiotherapy Safe

Connecticut Chapter AAPM

March 25, 2010

Howard Amols

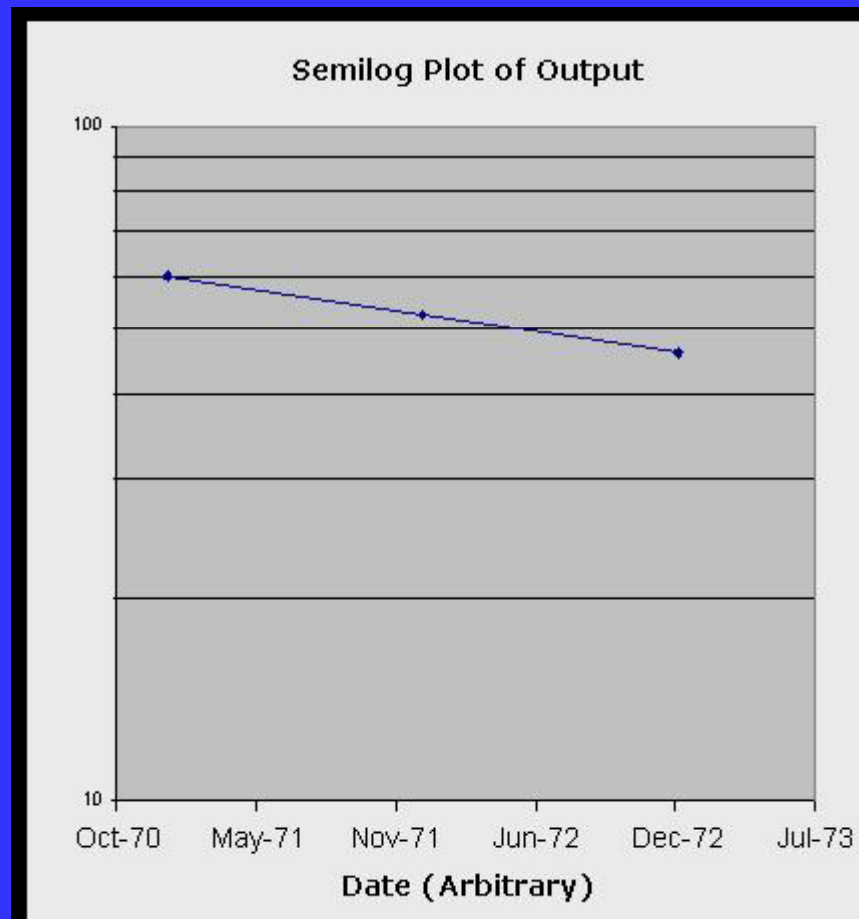
- Decay was determined from straight-line plot on **semi-log** graph paper with calendar ordinate

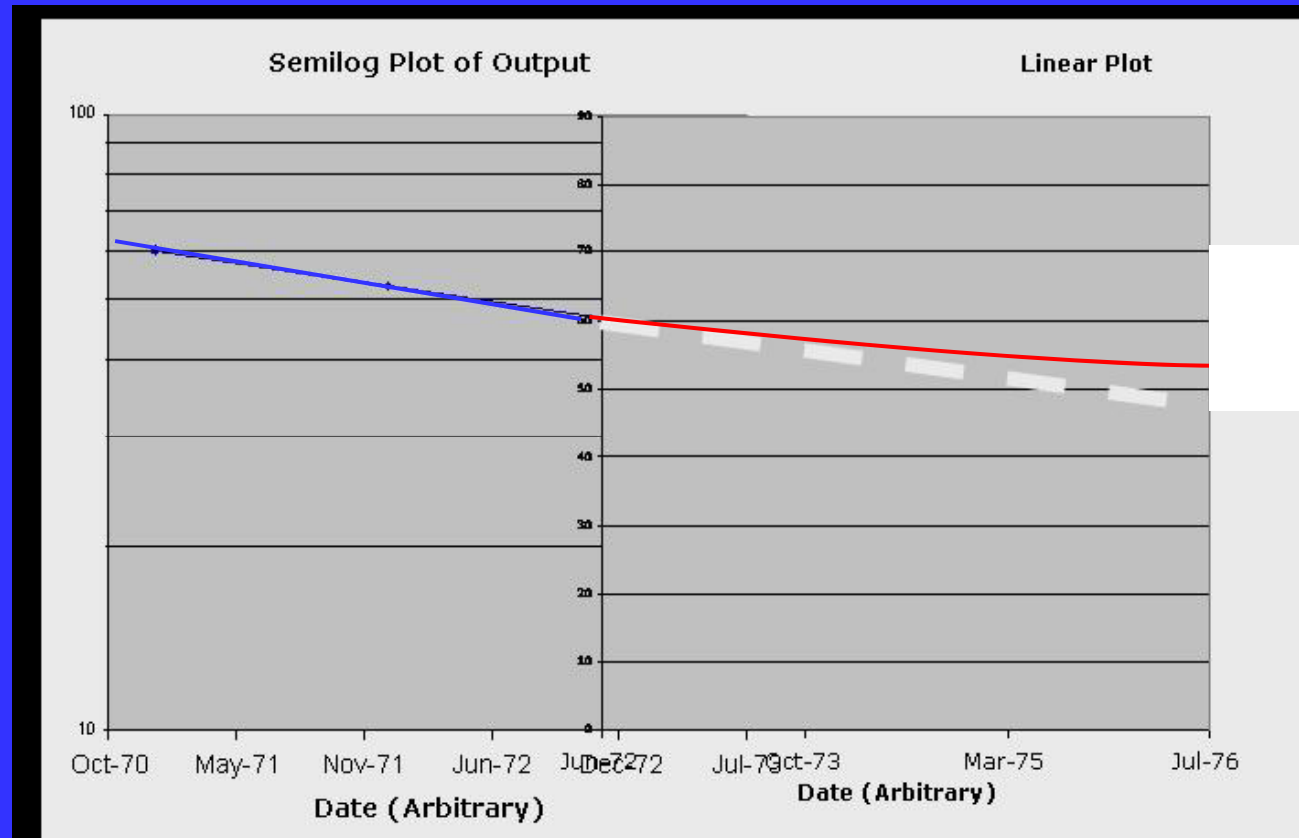
- When edge of graph paper was reached, physicist continued plot on **linear paper**

To compensate for the assumed lower output, technicians dialed in cobalt-60 exposure times that were, increasingly, too long. By March of 1975, the resulting radiation overdoses were averaging 10 per cent. And by January, 1976, when the problem was finally discovered, the overdoses were as high as 40 per cent.

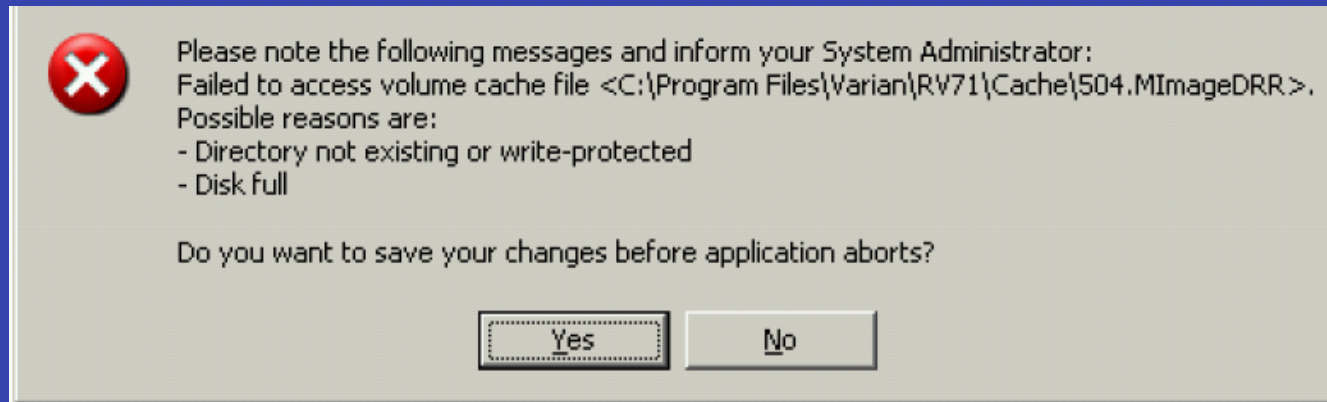
- **March 14, 11 a.m.**
 - An error message is displayed.
 - The user presses “Yes”, which begins a second, separate, save transaction.
 - MLC control point data is moved to the holding area.

Error message displayed. It's purpose is so that you can click `yes' or `ok' or `proceed'

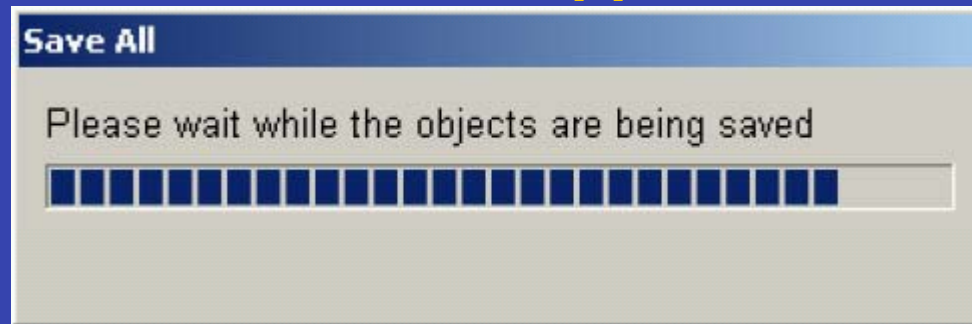
- **March 14, 11.a.m.**
 - The DRR is, however, still locked into the faulty first attempt to save.
 - This means the second save won't be able to complete.
 - The software would have **appeared to be frozen.**

The frozen state of the second "Save All" progress indication
